Manhole Inspection Summary

Manhole # S35WW_004MH

Insp Date: **1/9/07 10:19 AM**

Location Address: **3100 ABELL AVE**

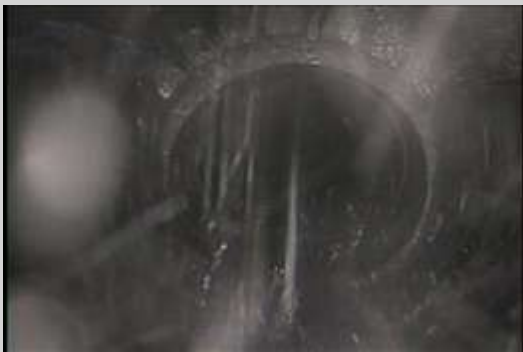
15 in. Circular Gravity Sewer Pipe Out @ 12 O'Clock

Pipe Material: **Clay** ☐ Pipe Lined

Invert Depth: **16.18** (ft.) Flow Characteristics: **Slow**

Deposits: ☒ None ☐ Mud ☐ Sludge ☐ Debris ☐ Grease

Infiltration: **None** Pipe Seal Cond: **Unknown**

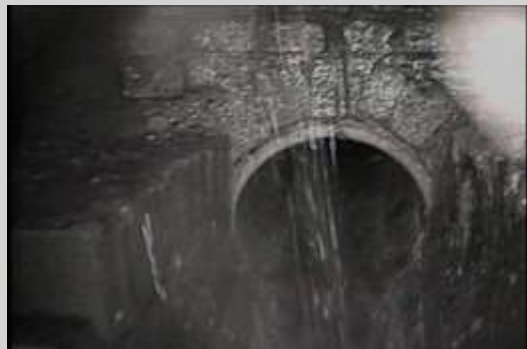
12 in. Circular Gravity Sewer

Pipe Material: **Clay**

Infiltration: **None**
